PROPERTY CONDITION ASSESSMENT
OF
WORLD TRADE CENTER PORTFOLIO

TWO WORLD TRADE CENTER

Merritt & Harris, Inc. Project Number 20-251E

Re: Due Diligence Physical Condition Survey
World Trade Center
New York, New York

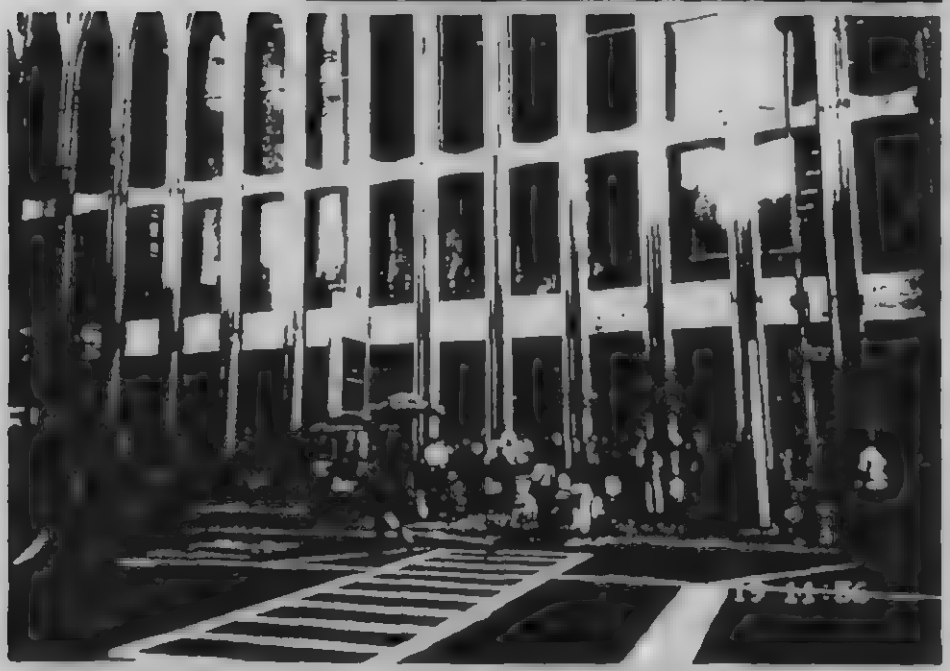
Photograph 1

Liberty Street
elevation

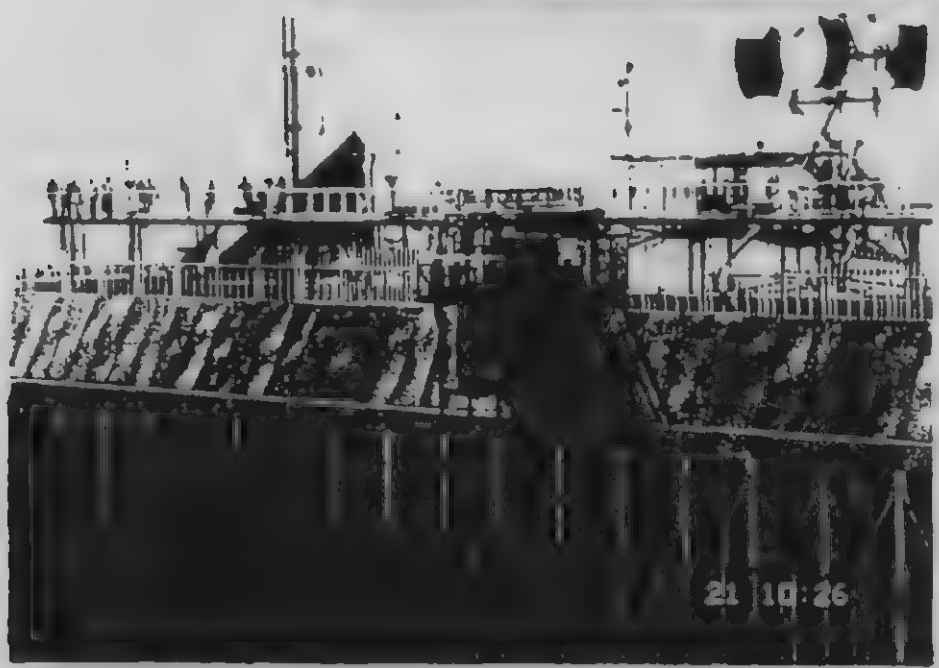
Photograph 3

Plaza elevation, Marriott hotel in background

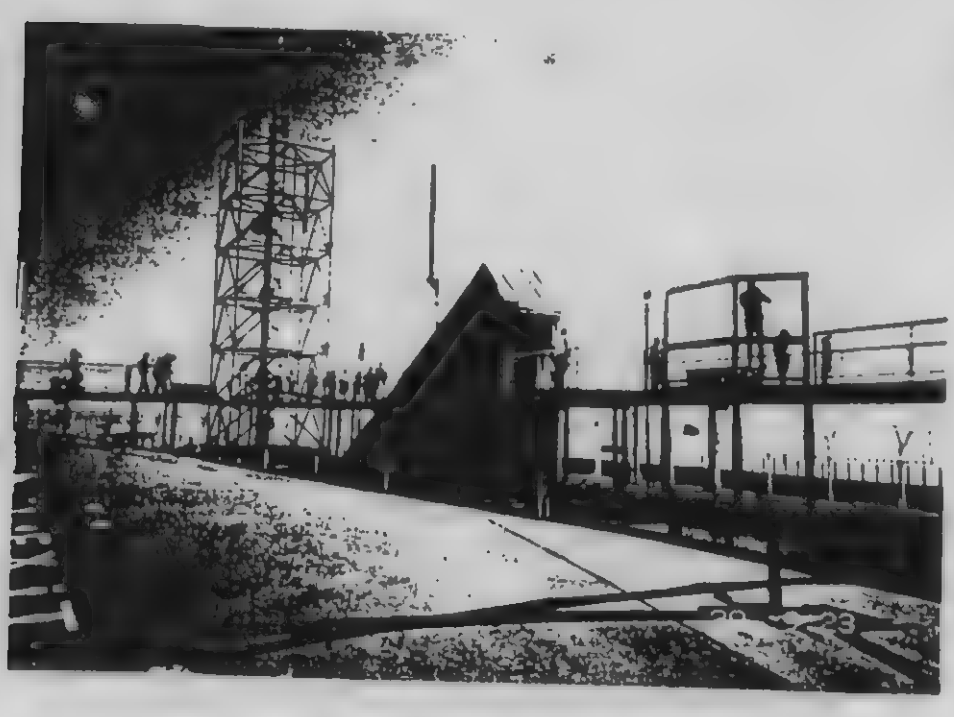
Photograph 4

Rooftop observation deck, window washing rig

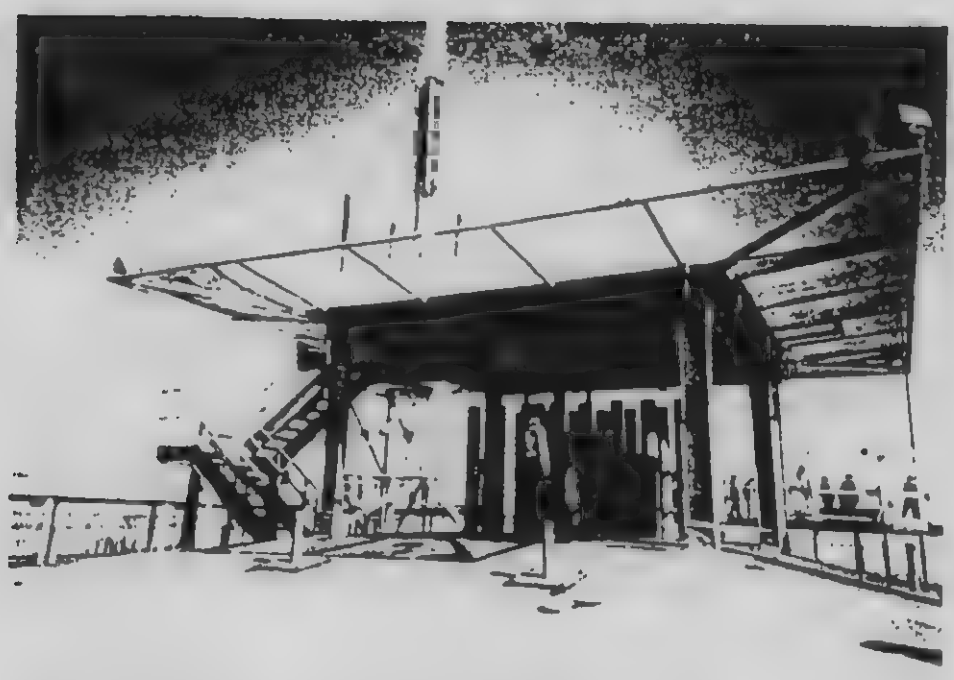
Photograph 5

Entrance to rooftop observation deck; note concrete covered roof

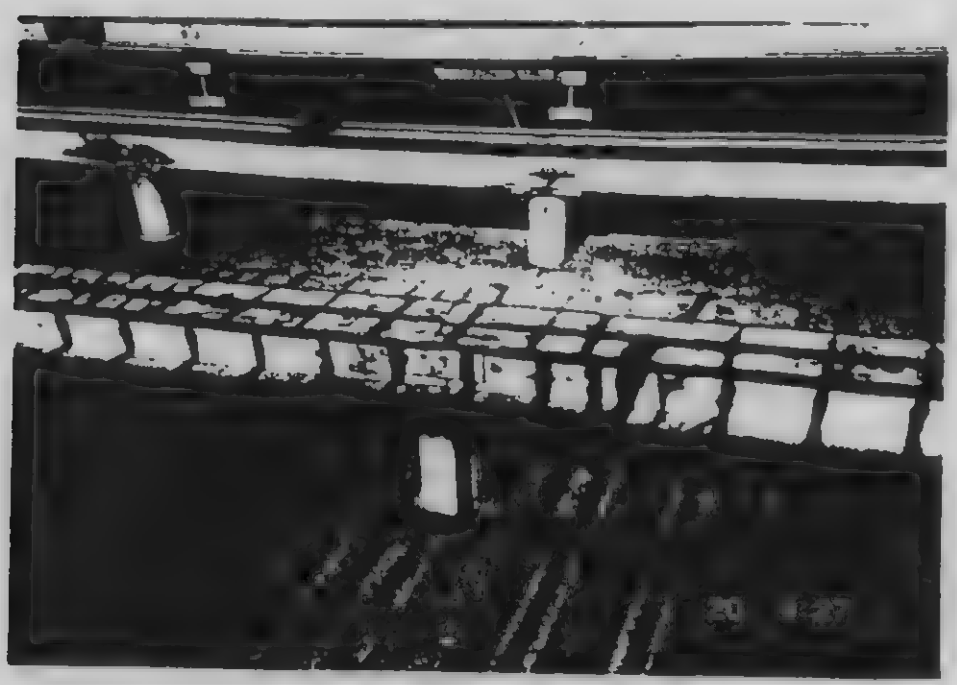
Photograph 7

Rusted window washing rig rails

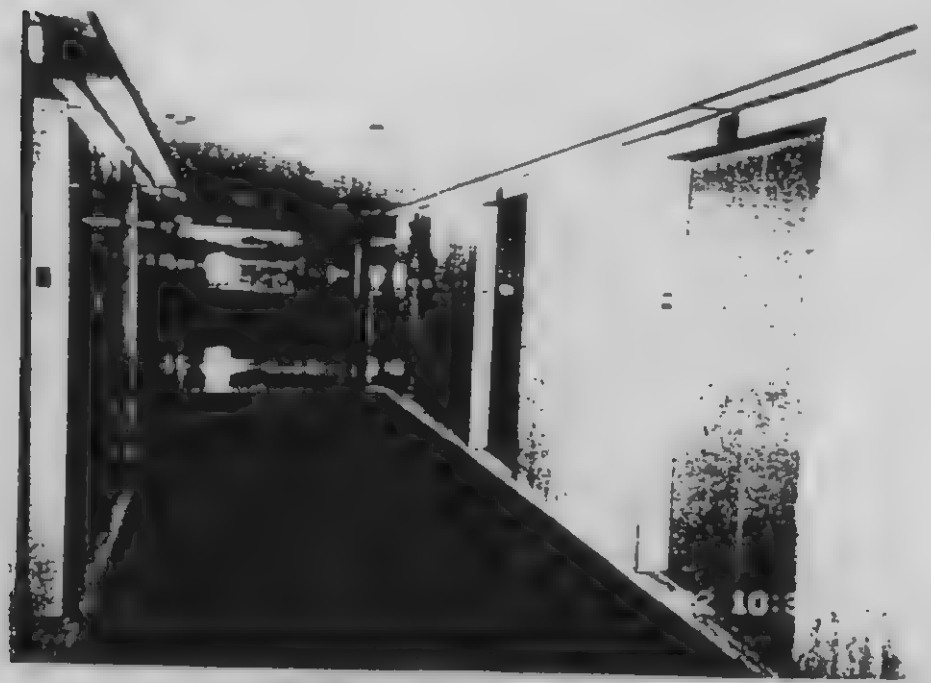
Photograph 16

Typical sky lobby

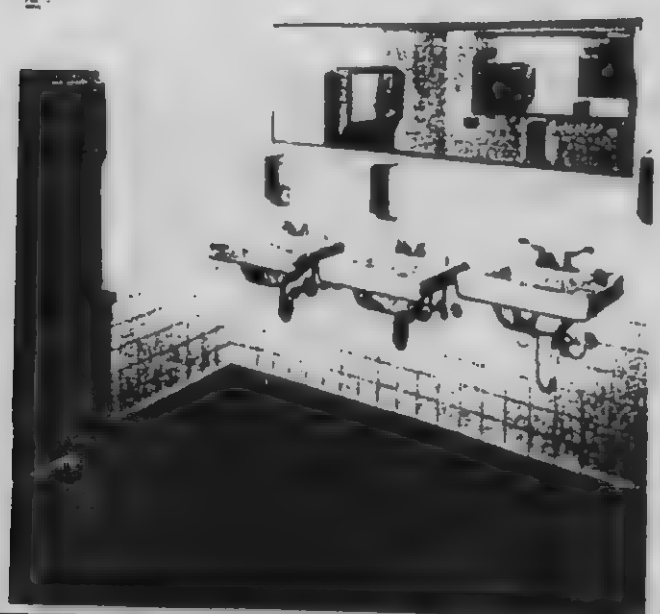
Photograph 18

Typical toilet room with original finishes

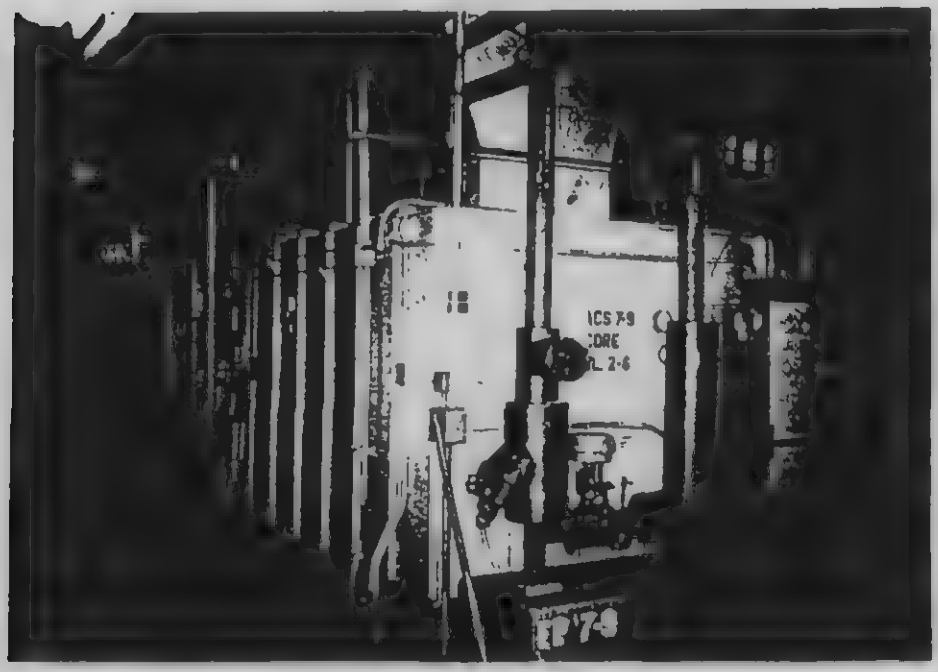
Photograph M1

Typical 7th floor mechanical room air handler and abandoned freeze protection pump system

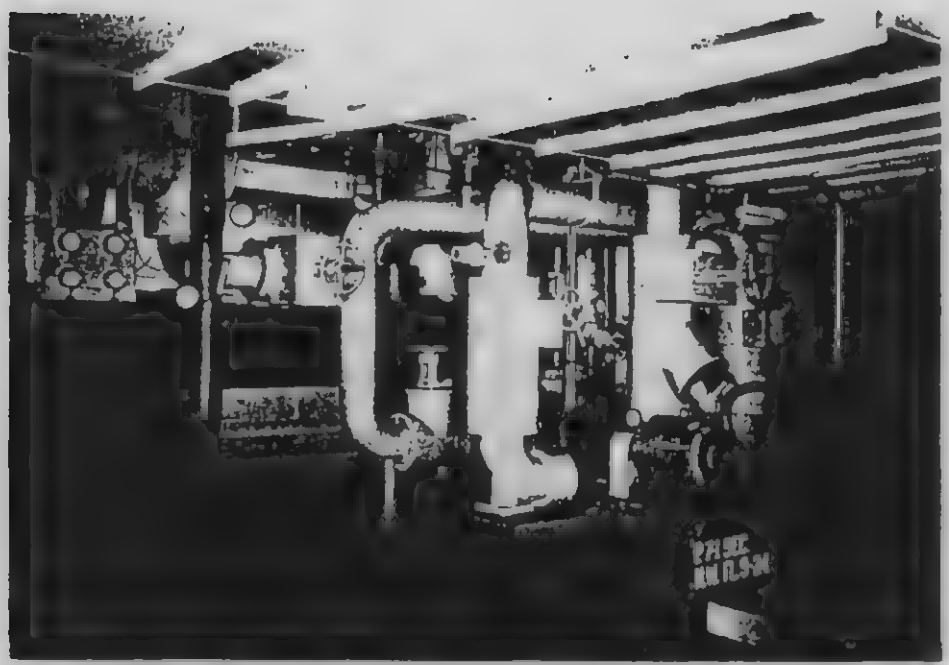
Photograph M3

Steam pressure reducing station

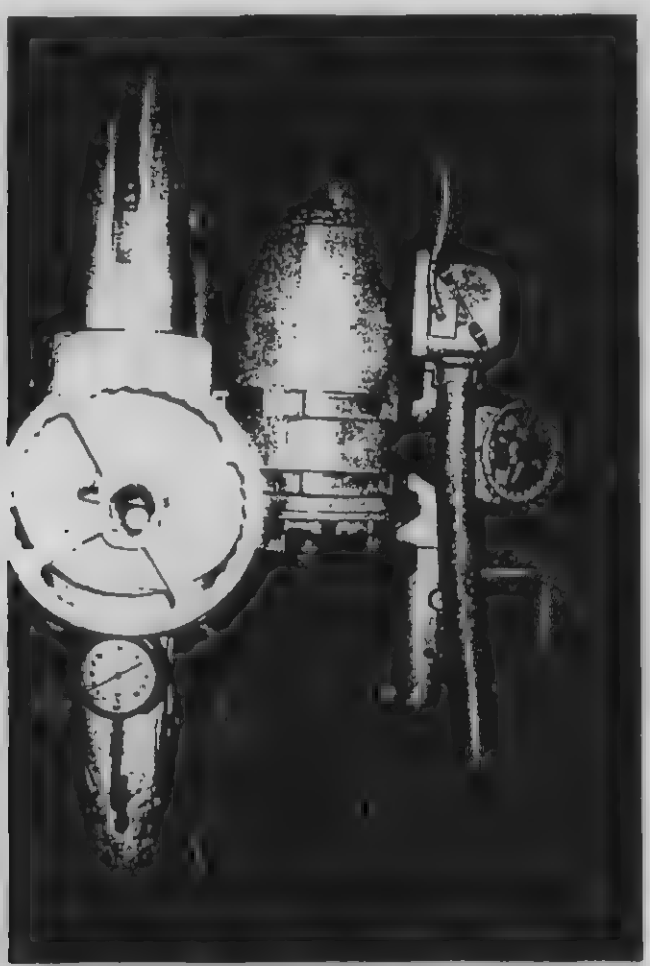
Photograph M8

Domestic water pressure reducing station

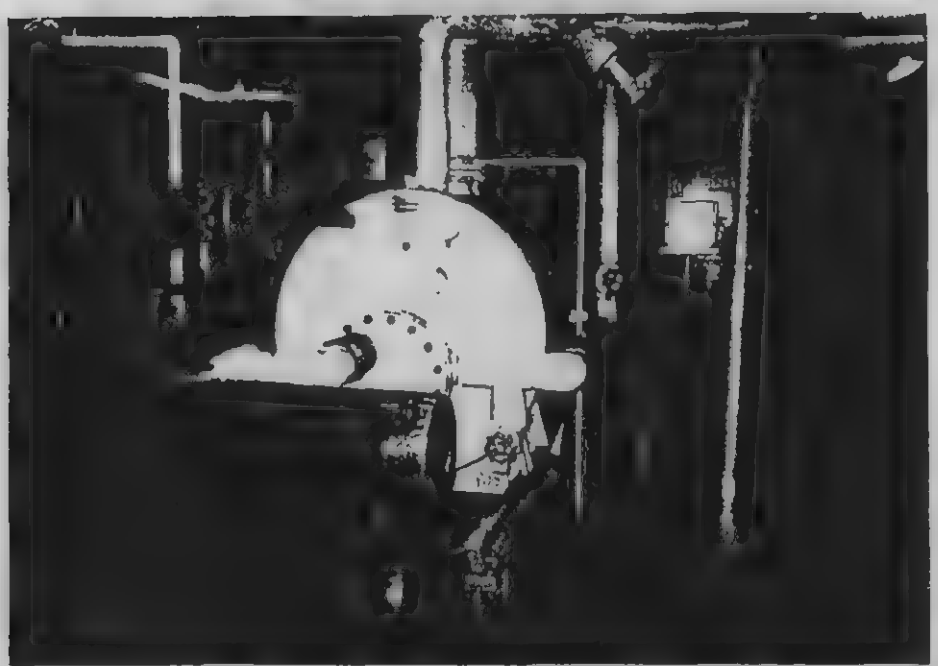
Photograph M9

Domestic water booster pump

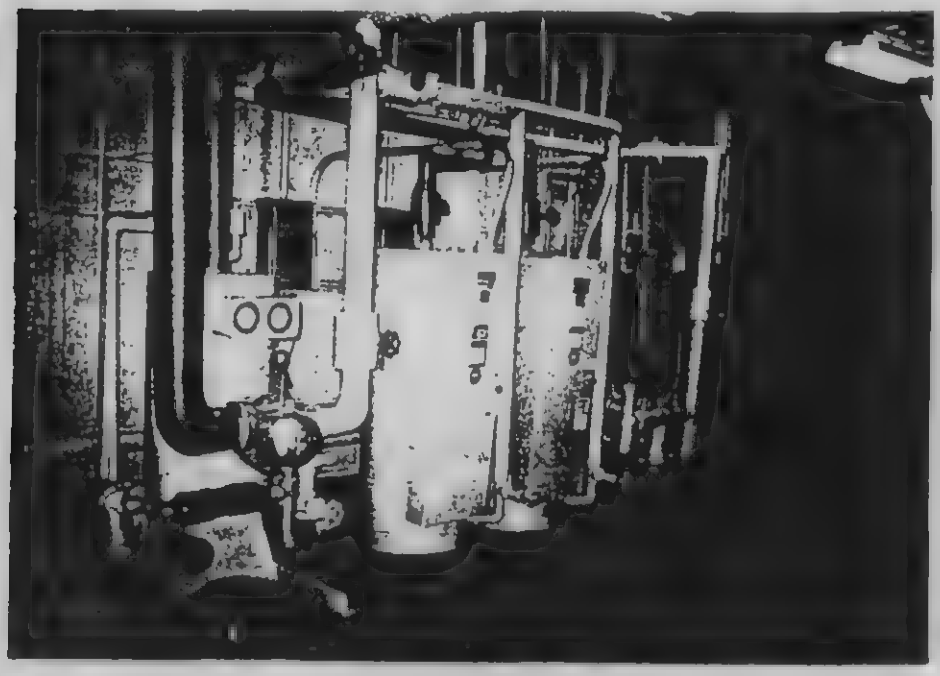
Photograph M10

Domestic water preheat tank

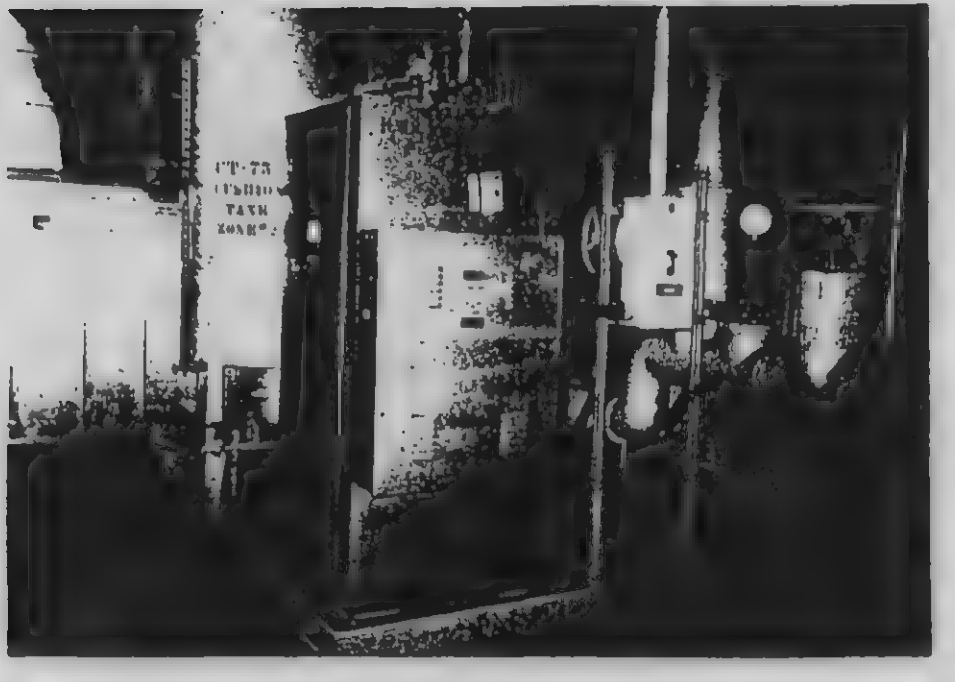
Photograph M11

Steam and electric domestic water heaters and circulating pumps

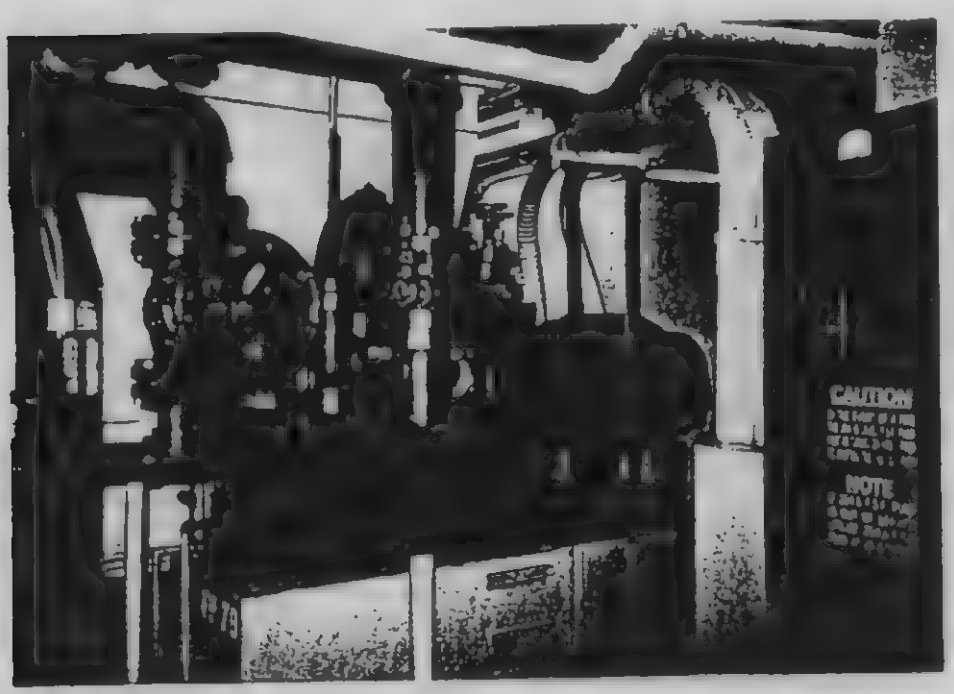
Photograph 12

Large electric water heater

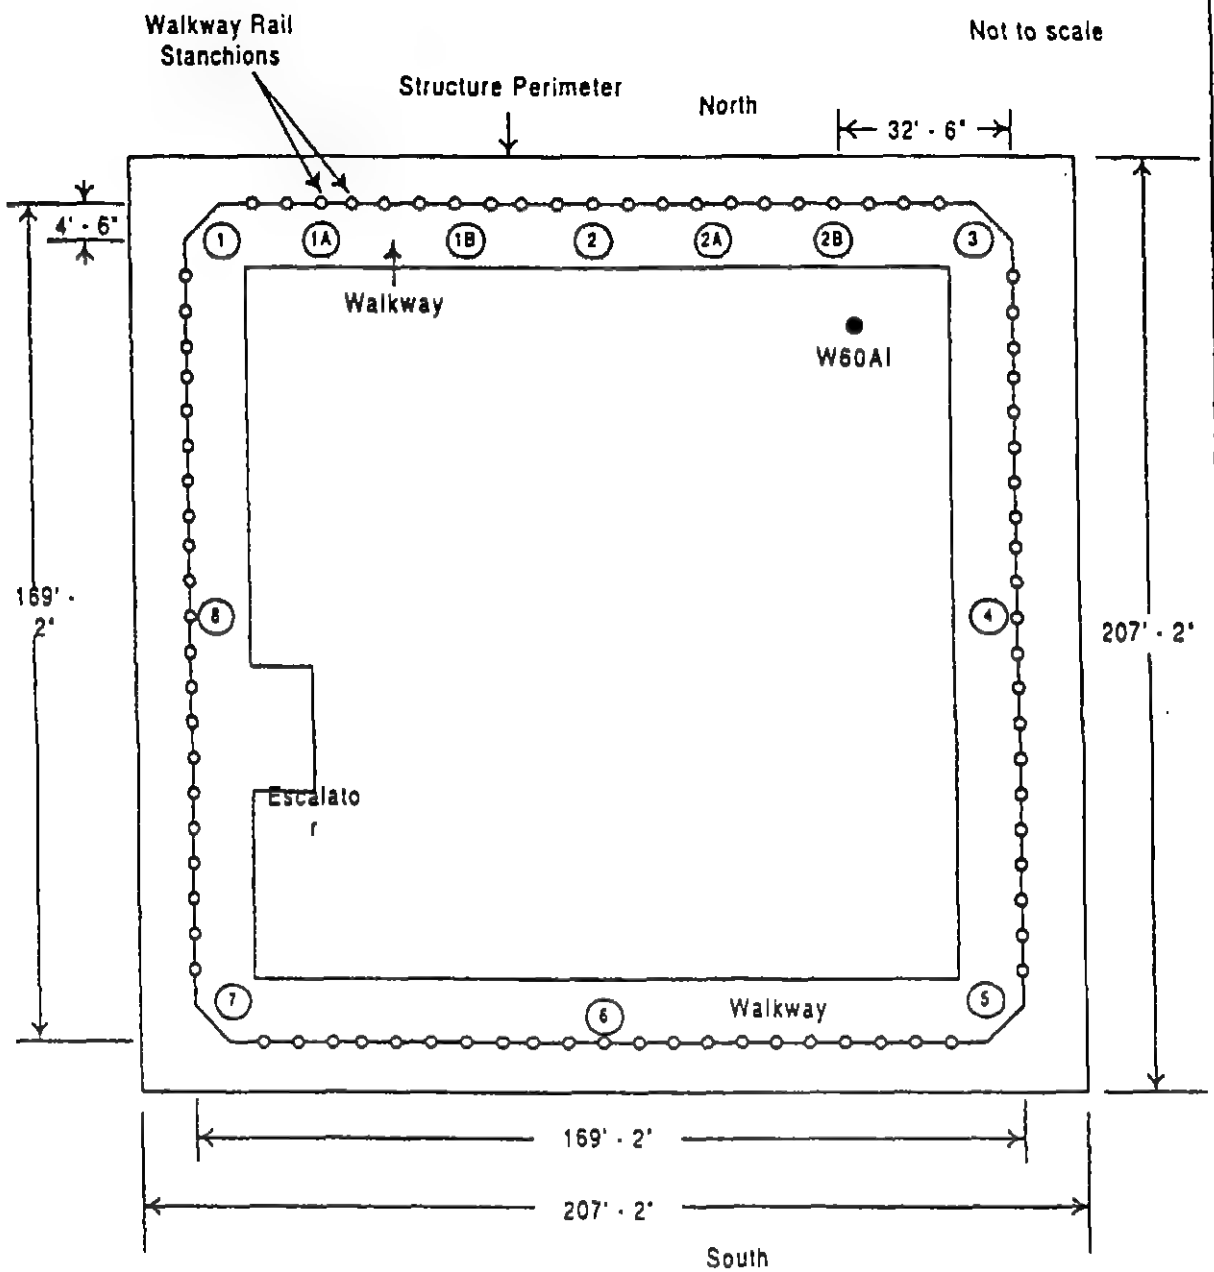
MEASUREMENT LOCATIONS
WORLD TRADE CENTER
SOUTH TOWER ROOFTOP OBSERVATION DECK WALKWAY

report is a tabulation of measured exposure data for the nine points measured during the survey. The location of each point specified in the tabulation of Figure 2 is identified in the diagram of Figure 5 of this report.

2. Observation deck walkway is approximately 9 feet above building roof level.

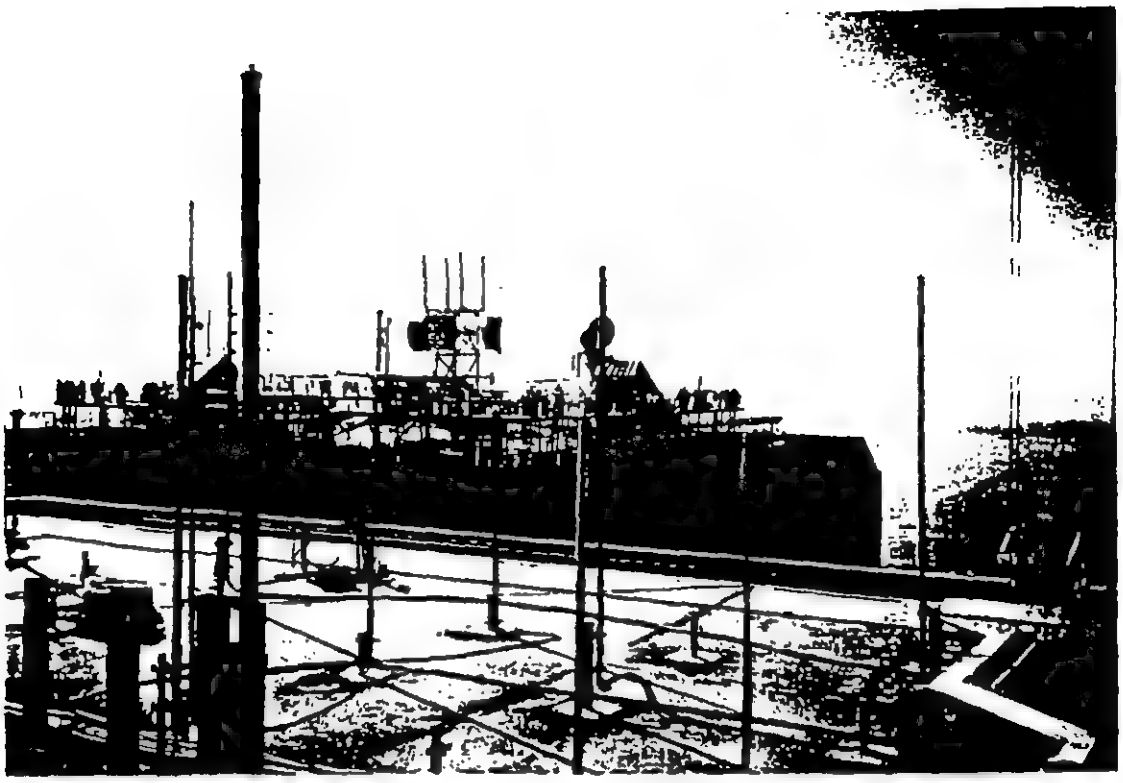
Work performed by Denny & Associates as reported March 17, 1999, indicates that the RF levels measured on the outside observation deck of Two World Trade Center, the South Tower (Photo #1), exceed "the maximum permissible level for general population/ uncontrolled exposure...for certain modes of auxiliary broadcast antenna use at WTC1 (North Tower)." They conclude that "The basic finding of this survey is that only the low band VHF television stations can operate using their auxiliary antennas without causing overexposure of the outdoor observation deck walkway at WTC2." That report indicates "Further investigation of the WTC2 exposure levels is warranted." "Since the initial objective of identifying procedures by which the broadcast stations at WTC1 can employ either their main or auxiliary antennas without exceeding the FCC MPE for general population/uncontrolled environments on the observation deck walkway at WTC2 has not been achieved...additional studies will permit broadcasters at WTC2 to move closer and ultimately fulfill their objectives of assuring compliance with the FCC rules."

Photo #1: Roof of One World Trade Center
with Two World Trade Center in background.
